# Safety Inspection Report

## North Thoresby Play Park

North Thoresby Parish Council

10 September 2025

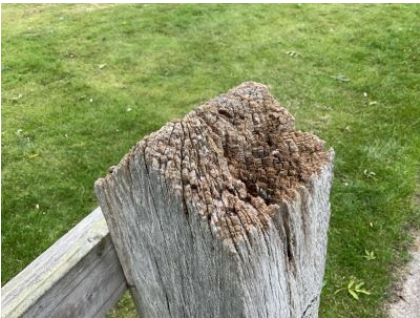
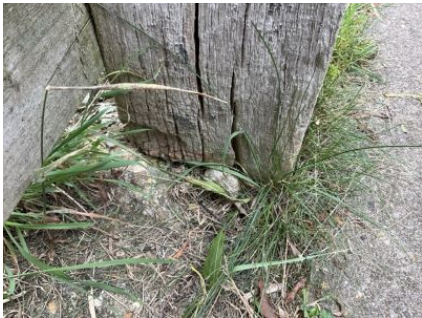
| Timber is rotting. |
| Monitor. |

| No reasonably practicable action is identified. |

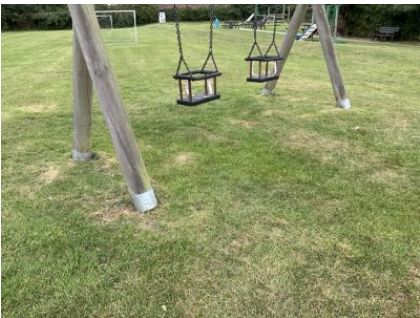
Metal post guards have been installed, preventing inspection of the timbers beneath them. Ensure these are exposed and inspected for decay.

Monitor.

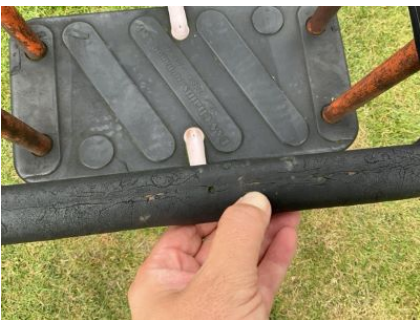
Swing seat rubber is deteriorating / degrading.

Replace when metal is exposed.

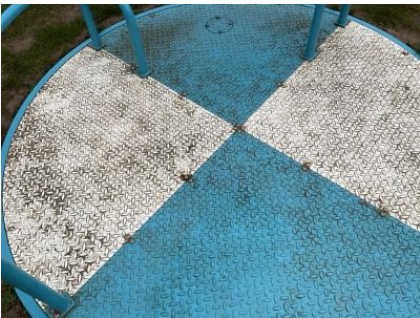
Algae growth giving slippery conditions.

Powerwashing is recommended. Care should be taken to ensure that the material can sustain high pressure washing.

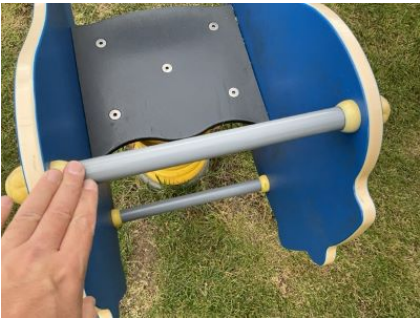
Fixtures loose or missing.

Handle bar and foot rest is loosening. Tighten.

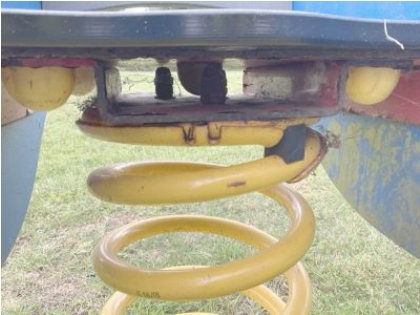
There is significant corrosion on this item.

De-scale back to good metal and coat with lead free paint, using appropriate precautions. Repairs may be necessary where corrosion is severe.

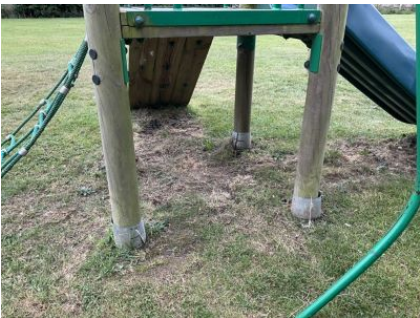
Metal post guards have been installed, preventing inspection of the timbers beneath them. Ensure these are exposed and inspected for decay.

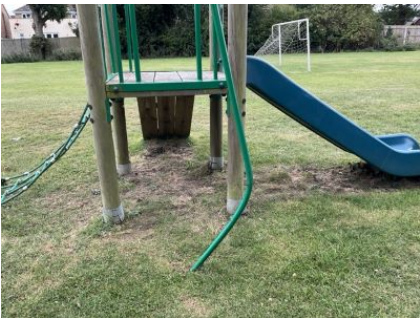
Fireman’s pole is severely bent. Repair.

Repair.

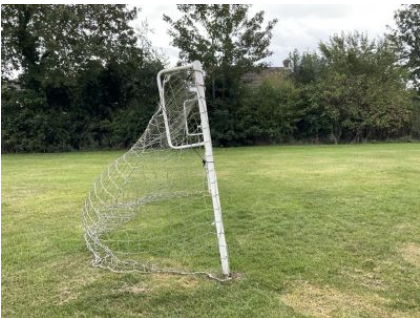
Loose in ground.

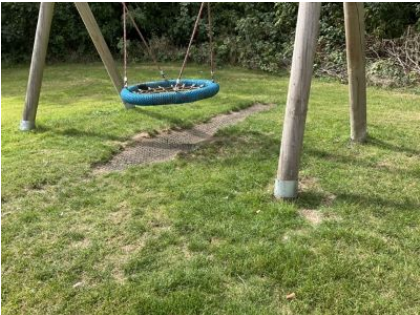
Additional comments are noted below.

Metal post guards have been installed, preventing inspection of the timbers beneath them. Ensure these are exposed and inspected for decay.

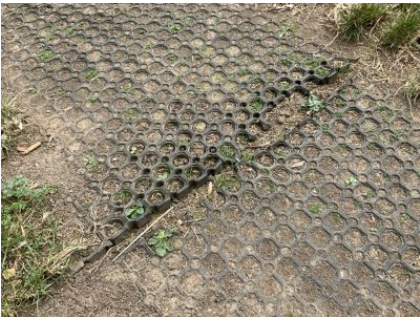
Surface needs repair.

Repair.

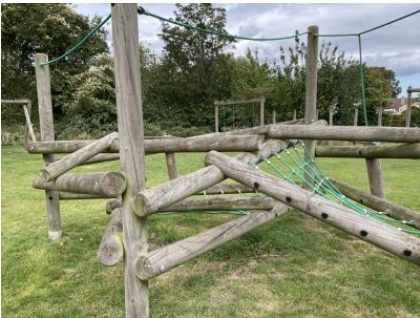
Bolt(s) loose.

Logs are starting to loosen. Tighten.

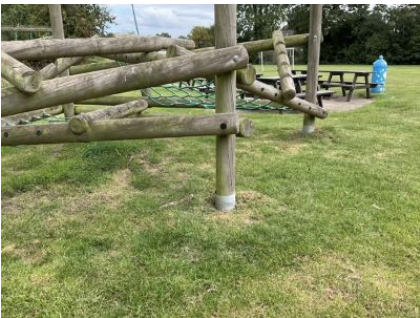
Additional comments are noted below.

Metal post guards have been installed, preventing inspection of the timbers beneath them. Ensure these are exposed and inspected for decay.

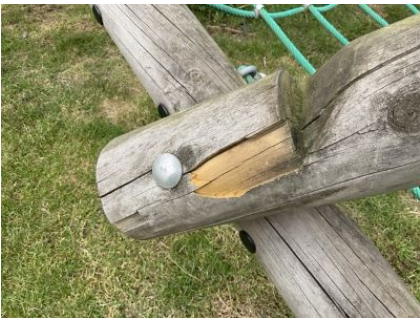
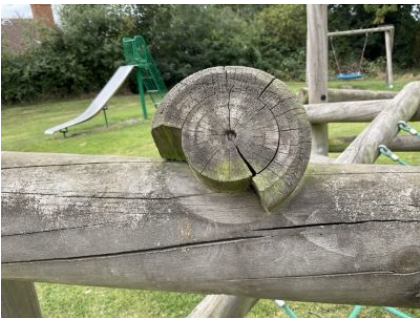
Diagonal beam x 2 are splintered at the top and bottom. Recommend replacement as the inner wood is starting to open up and could split further apart.

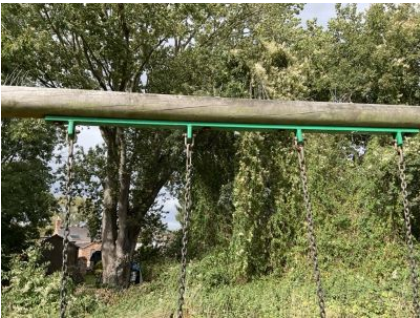
Bolt(s) loose.

Steel beam is loose to cross beam. Tighten bolts.

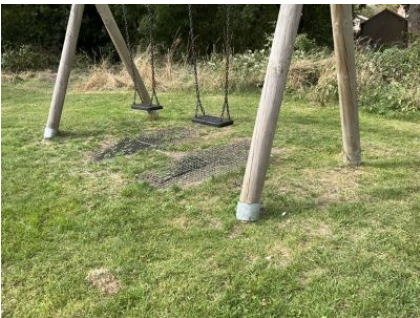
Additional comments are noted below.

Metal post guards have been installed, preventing inspection of the timbers beneath them. Ensure these are exposed and inspected for decay.

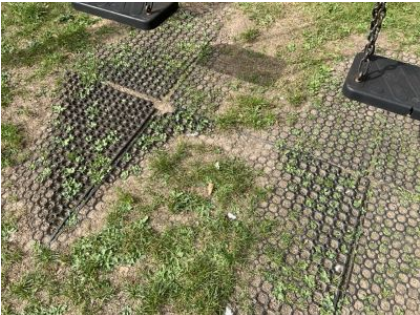
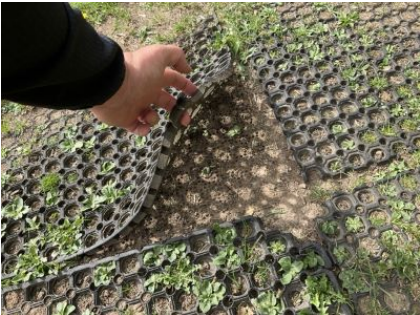
Surface needs repair.

Repair.

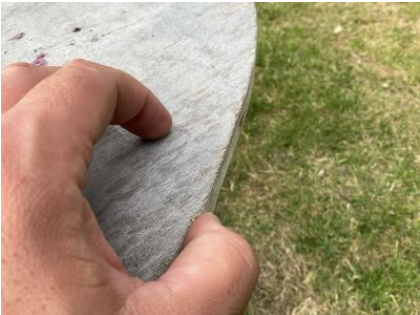
Damaged laminate exposing non radiused edge on platform. Repair.

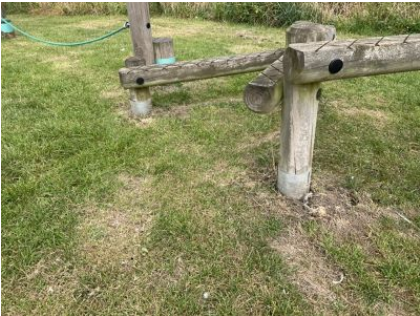
Metal post guards have been installed, preventing inspection of the timbers beneath them. Ensure these are exposed and inspected for decay.

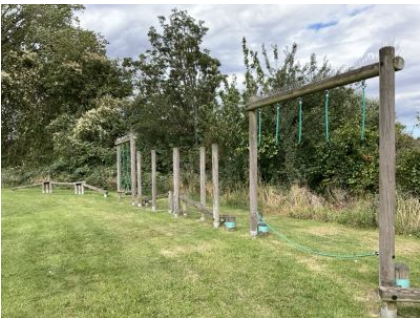
Loose in ground.

Hanging rope support is extremely loose in ground. Reset.  
Other supports on suspended log walk are also loosening in ground.

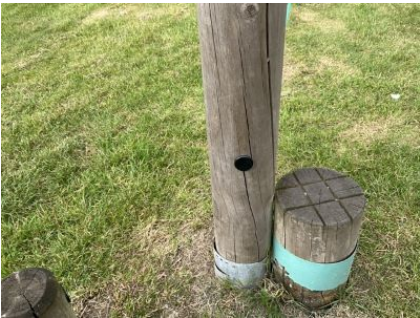
This equipment relies on one post for its stability. Special attention should be paid to maintenance (e.g. by monitoring degradation) and if necessary decommissioning the item before the end of its operating life. This is a requirement of the British Standard.

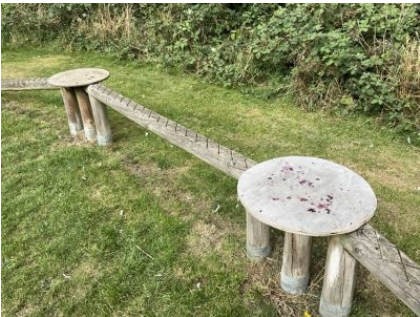
Bolt(s) loose.

Platforms are loose. Tighten.

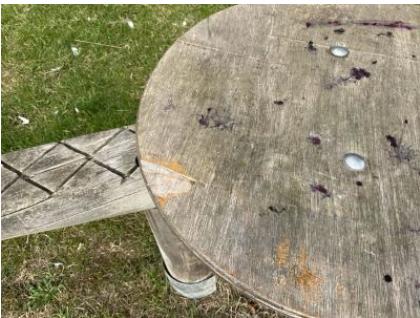
Laminate damaged.

Rub down and treat damaged edges.

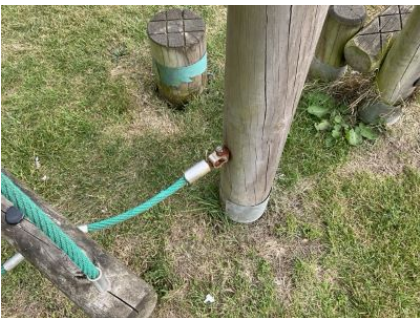
Bolt(s) loose.

Suspended log walk eye bolts are loose. Tighten.
