**S19-979**

**Station Road,  
North Thoresby**

Section 19 Flood and Water  
Management Act 2010

Date Prepared – 07/05/2025

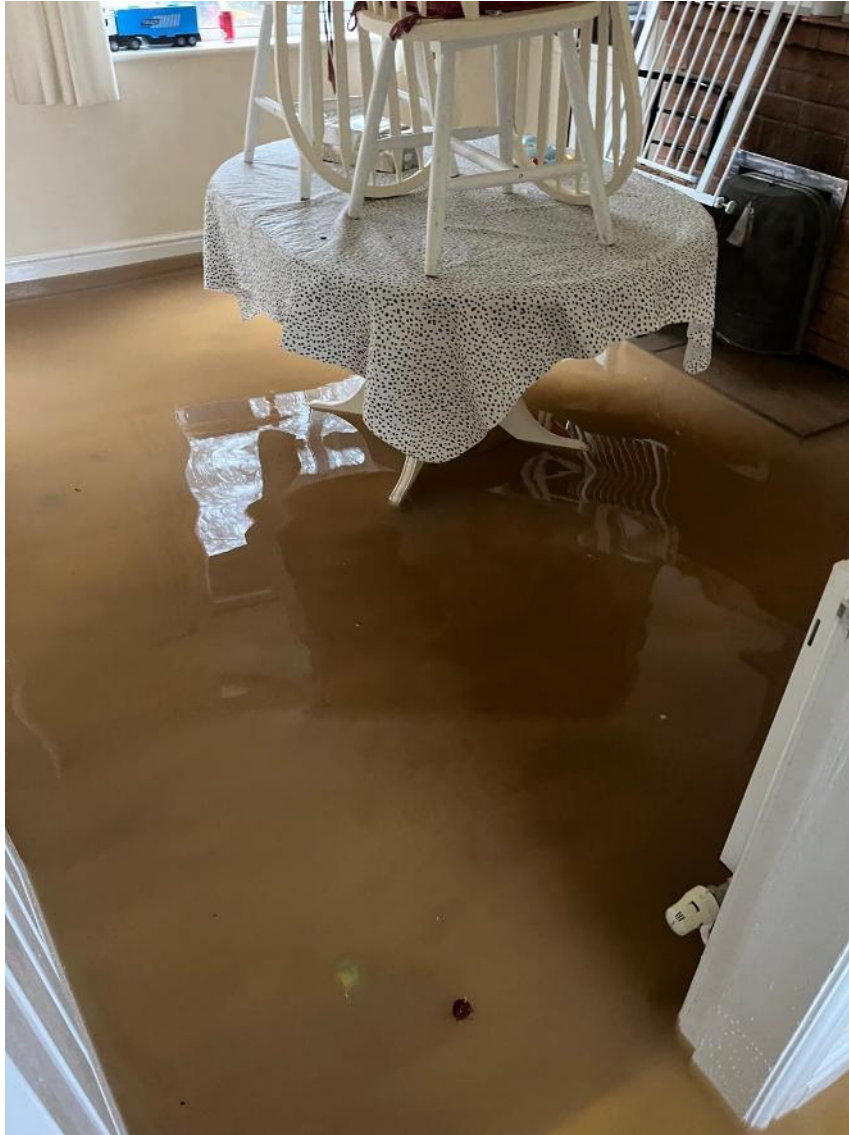
*(Figure 10 – Internal flooding within Property A, as provided by the resident)*

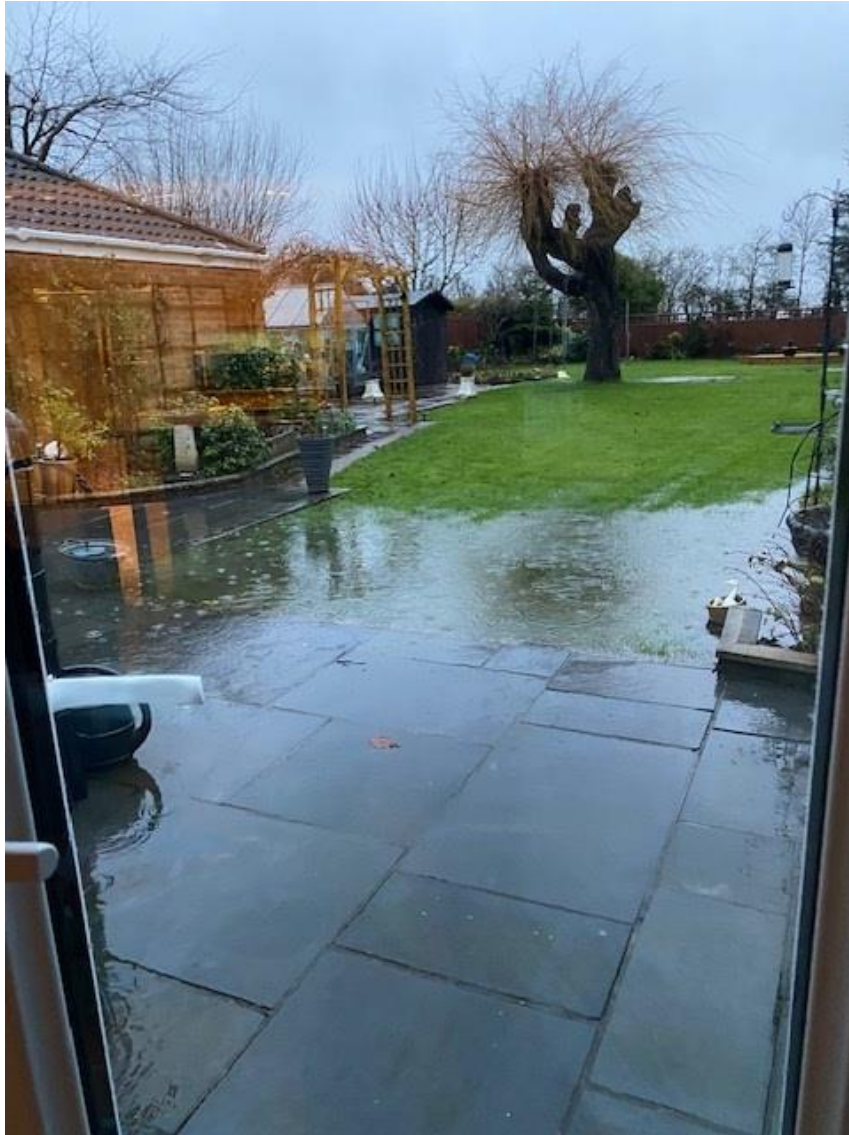
*(Figure 11 – Flooding in the rear garden at Property C, as provided by the resident; facing north)*

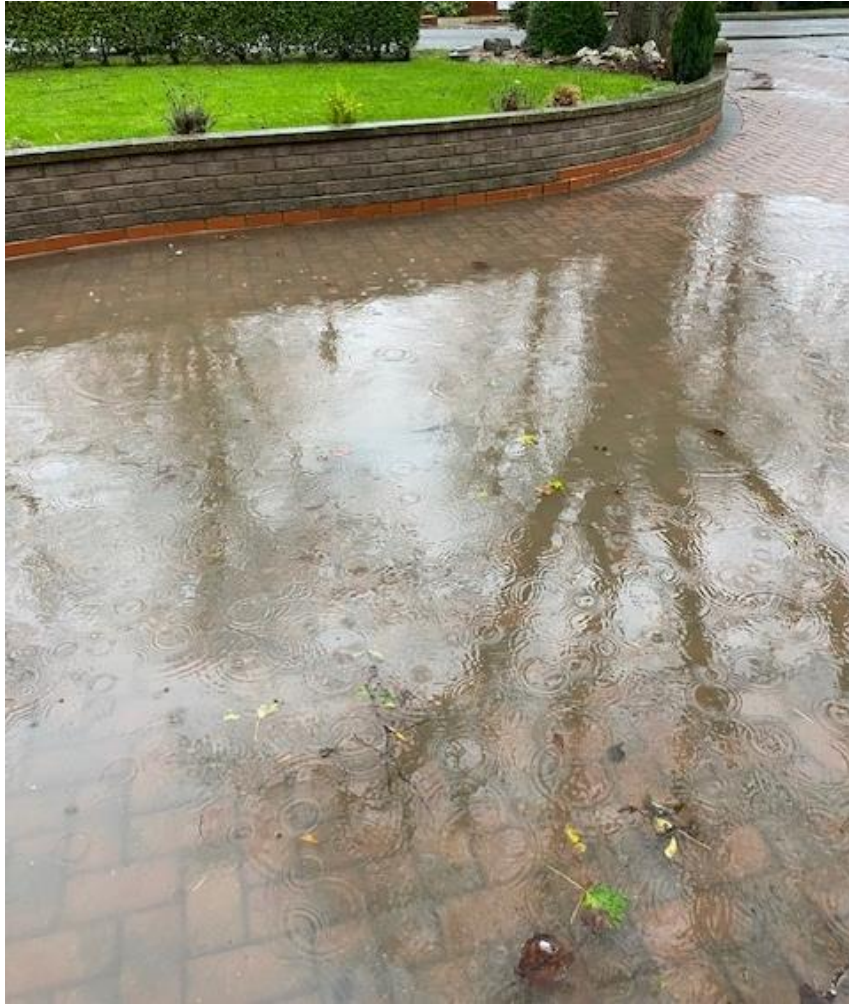
*(Figure 12 – Flooding in the front driveway at Property C, as provided by the resident; facing south)*

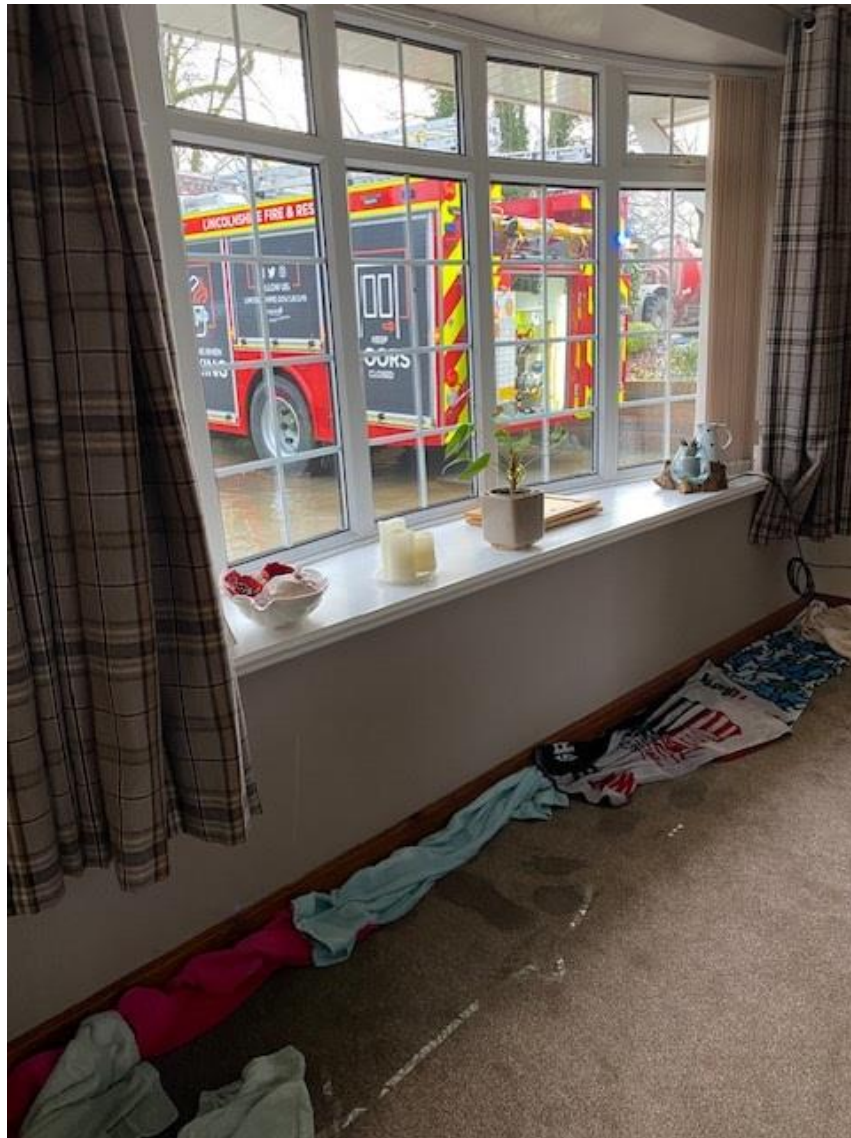
The resident at Property C reported that flood waters remained in the dwelling until 23:00 on 06 January. Seepage occurred on the ground floor of the dwelling due to external flood waters exceeding the damp proof course and entering via the walls and floor; flood waters did not exceed the building thresholds, although they were noted to be close. Flood waters reached a maximum external depth of 250 mm, with a depth of c. 100 mm adjacent to the front door (Figures 11, 12 and 15). Flood waters were noted to breach the entrance to the detached garage.

*(Figure 13 – Seepage at Property C, as provided by the resident)*

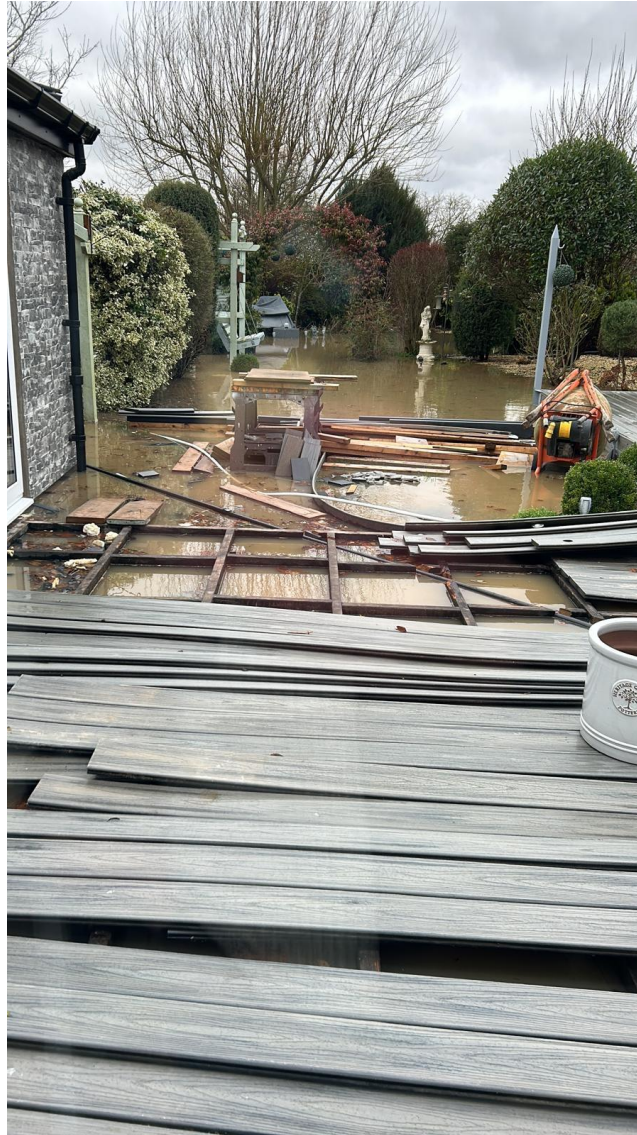
*(Figure 16 – Flooding in the rear garden at Property D, as provided by the resident; facing north)*

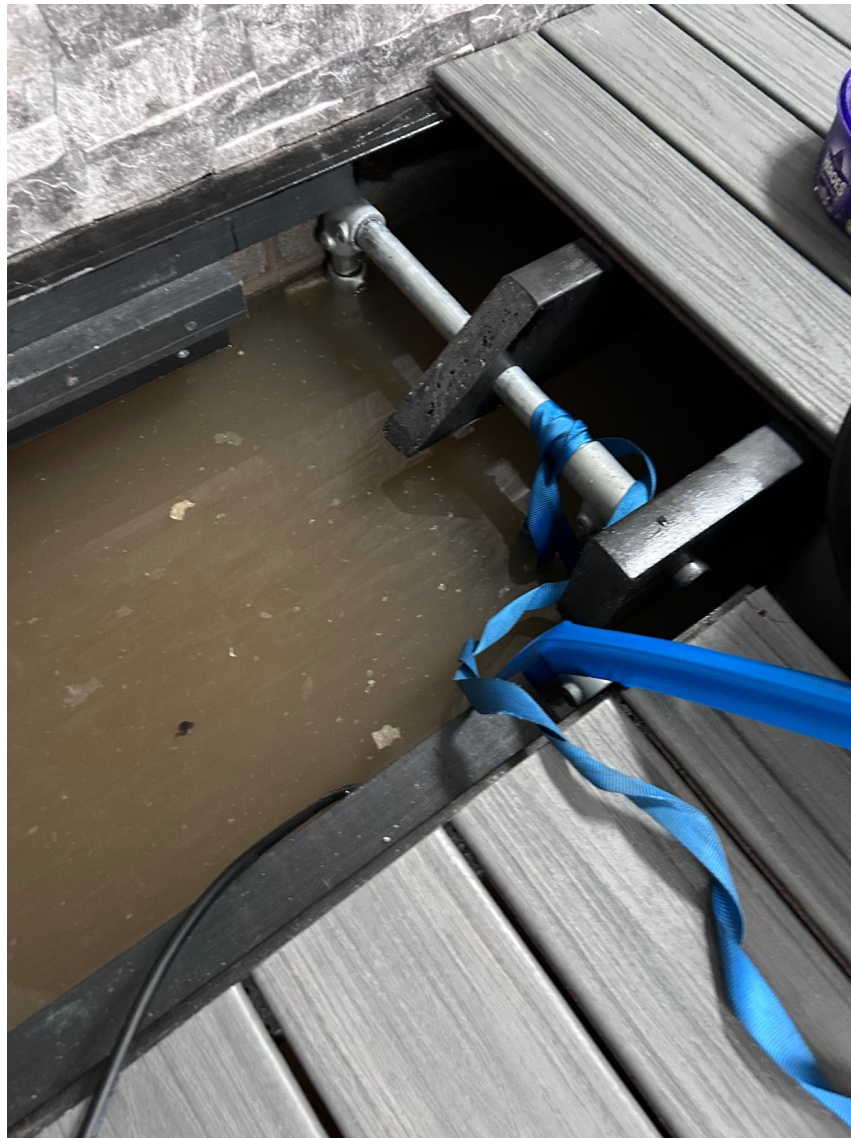
*(Figure 17 – Flooding beneath the floorboards in the extension at Property D, as provided with the resident)*

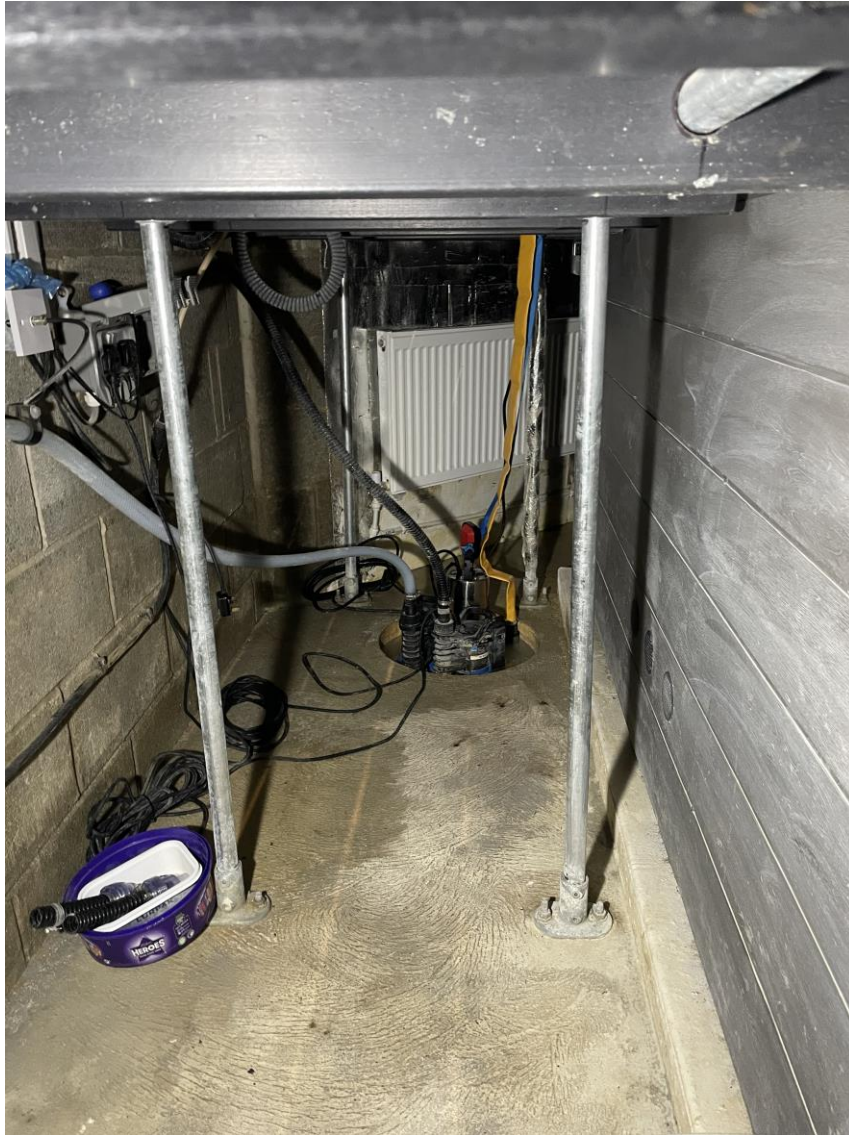
*(Photograph 4 – Sump and pump beneath the swim spa at Property D, which still contained water at the time of the Site visit)*

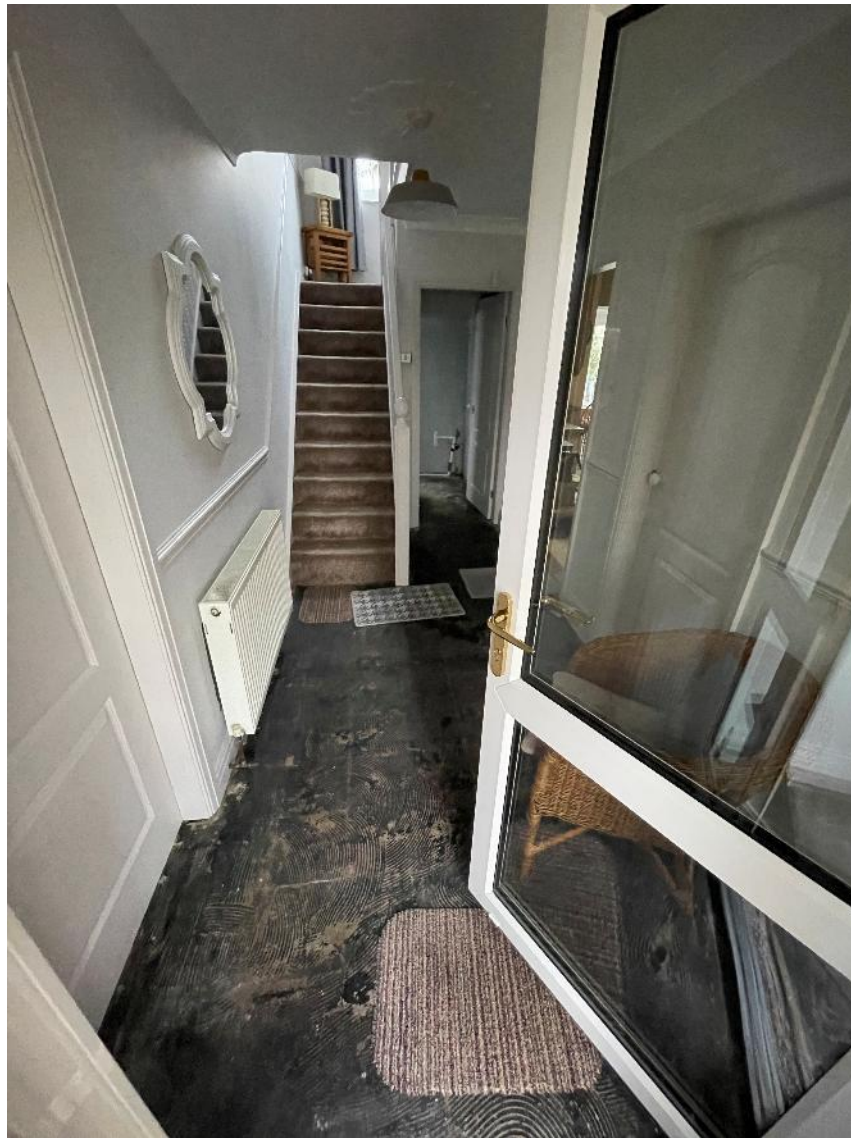
*(Photograph 6 – Flood damage at Property C)*

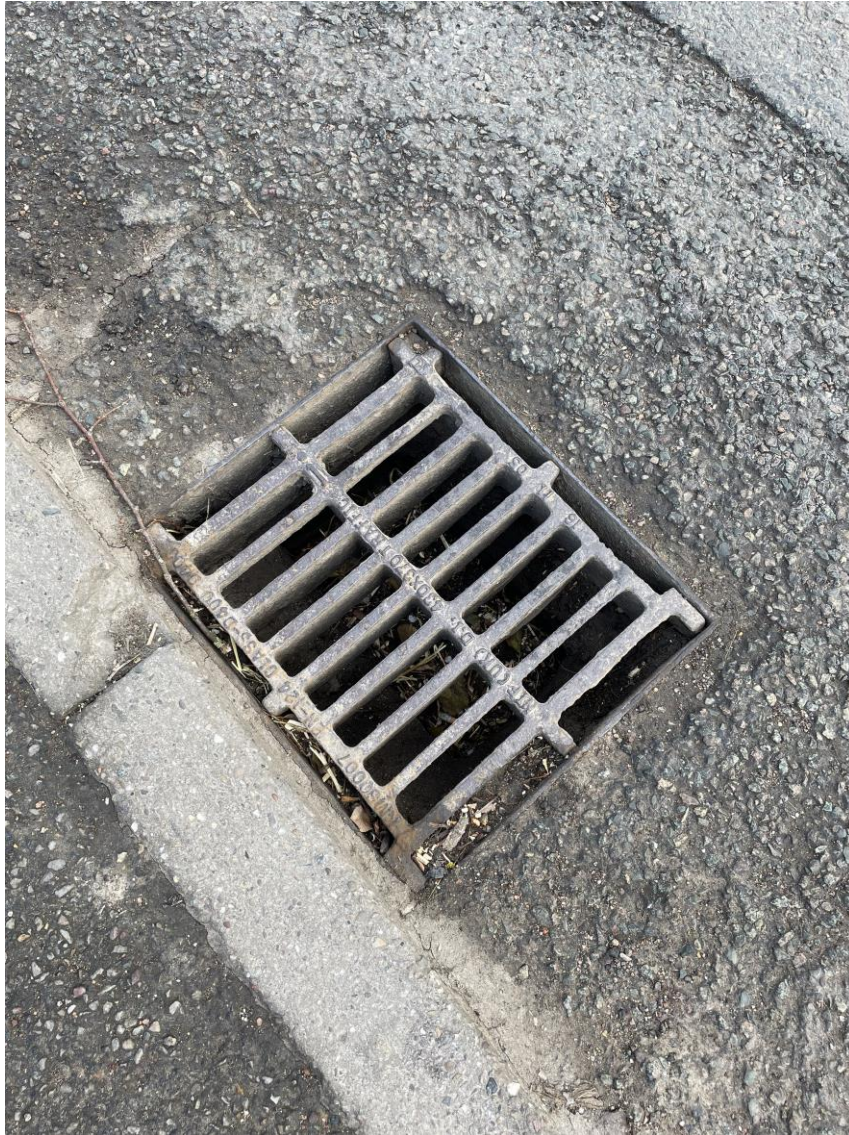
The Site visit confirmed that gullies and offlets are present along Station Road in the same arrangement as included within LCC records. The gullies and offlets generally appeared to be in reasonable condition (beyond occasional silt / debris), although one gully, adjacent to Property D, appeared to be visibly partially blocked (Photograph 7 in Appendix 7.3), which was also reported by a resident.

The capacity of the highway drainage system could be limited by any defect, damage or blockage within the assets maintained by LCC and / or the piped drainage system of unknown ownership into which they discharge. One gully was observed to be partially blocked with silt and plant debris during the visit, although the others appeared to be in reasonable condition. Any blockages could reduce the capacity of the drains and contribute to their exceedance during rainfall events.

*(Photograph 7 – Gully outside Property D, which appeared to be partially blocked with silt and plant debris)*

Following the inspection of the highway drainage assets, remedial work should be considered to address any defect, damage or misconnection. Upgrades may also be required to increase the capacity within the network, having regard to current design standards, capacity of the receiving drainage network, and legislative requirements.

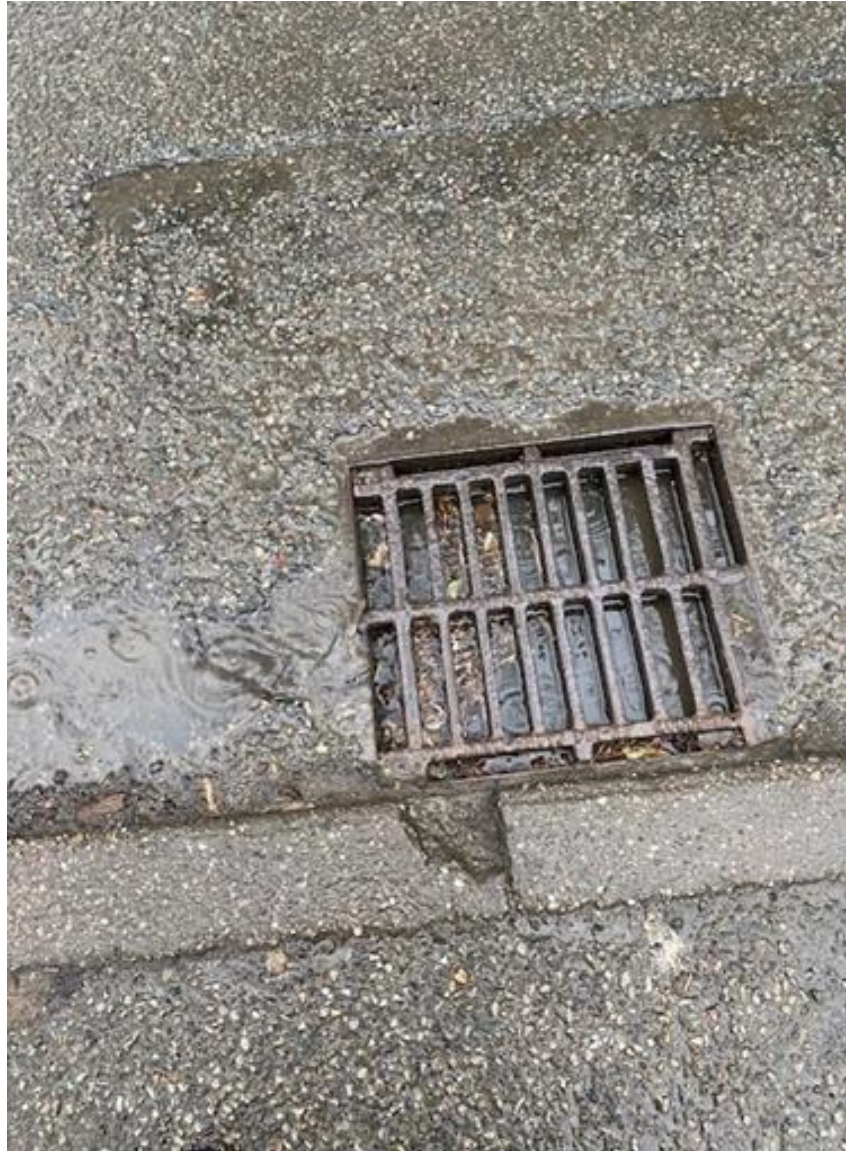
The resident of Property C provided additional photographs and videos on 15 April 2025 following a period of rainfall in the early hours of the same day. This indicated that the highway gullies were at capacity and surface water was ponding along the kerb line and flowing along the driveway adjacent to the property (photograph 8). It was noted that the highway gully adjacent to the driveway of Property D was blocked with “rubble”, with flows travelling from this asset to the lower elevation of the adjacent Property C (photograph 9).

*(Photograph 9 – Gully outside Property D at full capacity during 15<sup>th</sup> of April, indicating potential blockage)*
