# Safety Inspection Report

## North Thoresby Play Park

North Thoresby Parish Council

10 September 2025

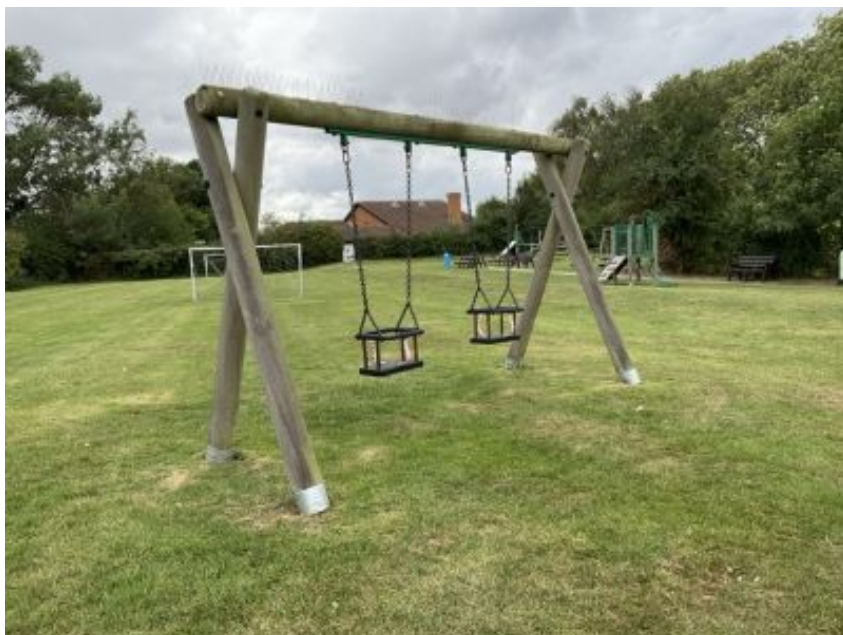
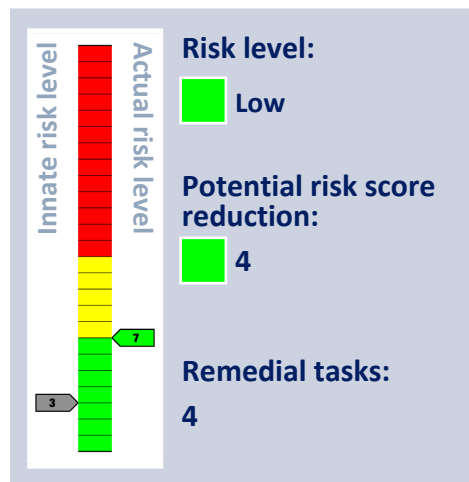
# Swing - Toddler - 1 Log Bay 2 Seat

1. Swing seat rubber is deteriorating / degrading.
2. There are natural splits / shakes in the timbers.

Swing seat rubber is deteriorating / degrading.

Replace when metal is exposed.

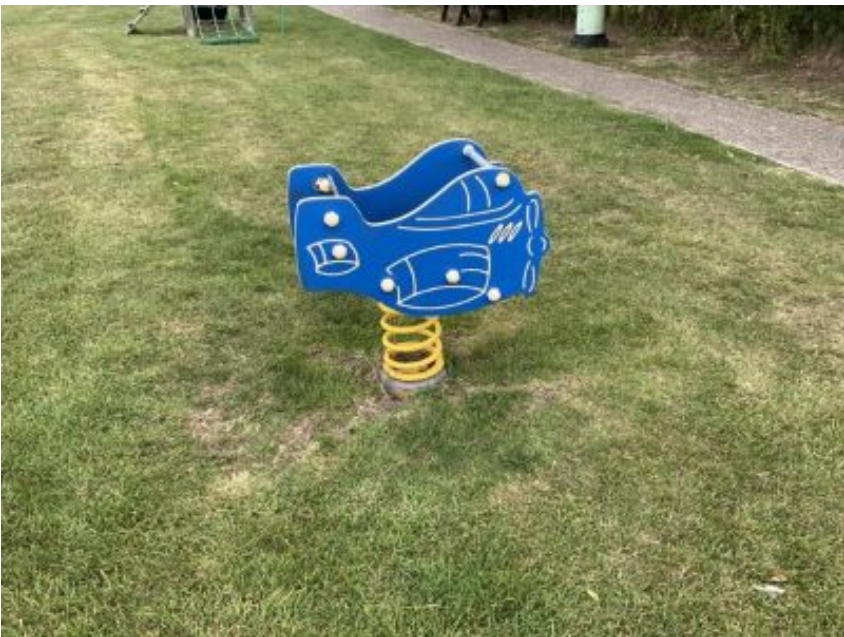
# Rocker - Plane

Fixtures loose or missing.

Handle bar and foot rest is loosening. Tighten.

There is significant corrosion on this item.

De-scale back to good metal and coat with lead free paint, using appropriate precautions. Repairs may be necessary where corrosion is severe.

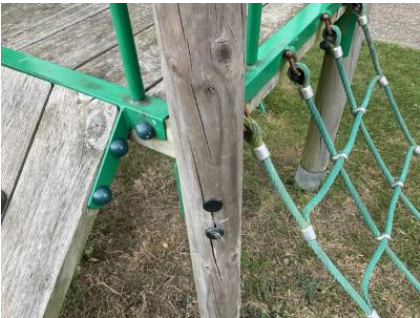
Loose in ground.

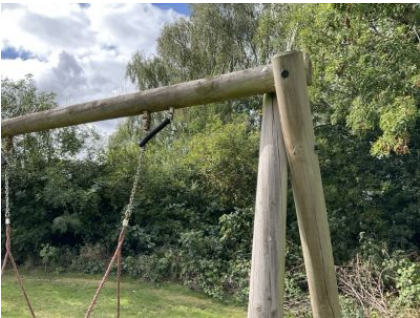
Surface needs repair.

Repair.

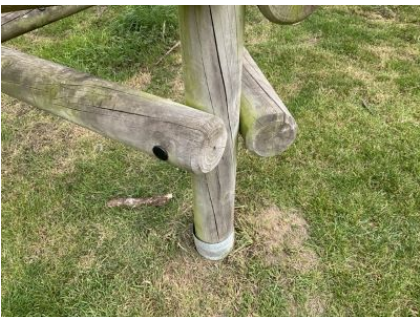
Diagonal beam x 2 are splintered at the top and bottom. Recommend replacement as the inner wood is starting to open up and could split further apart.

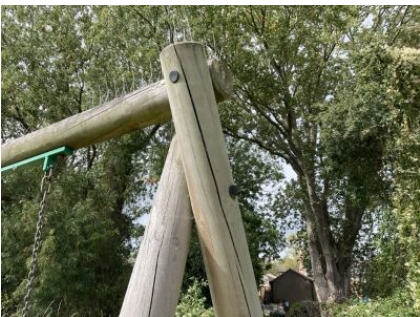
Surface needs repair.

Repair.

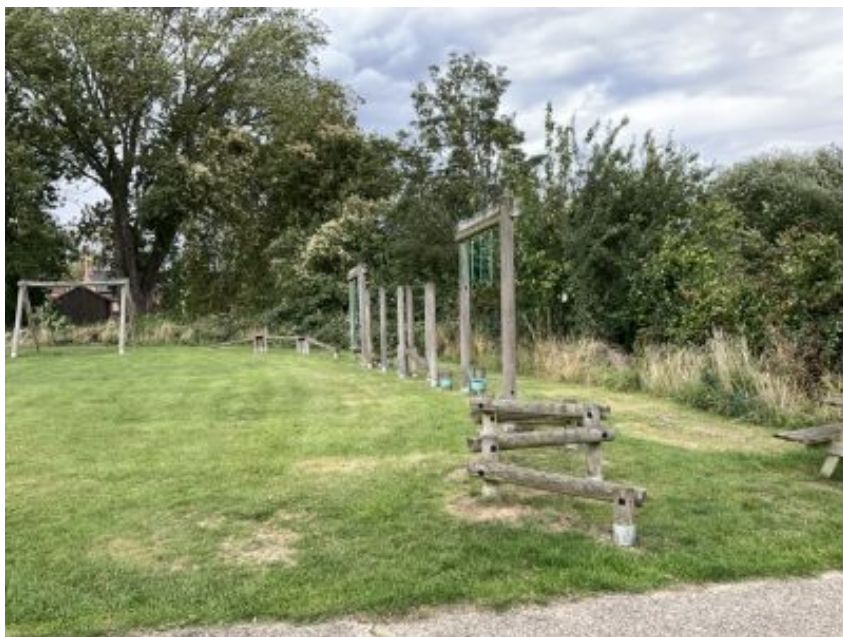
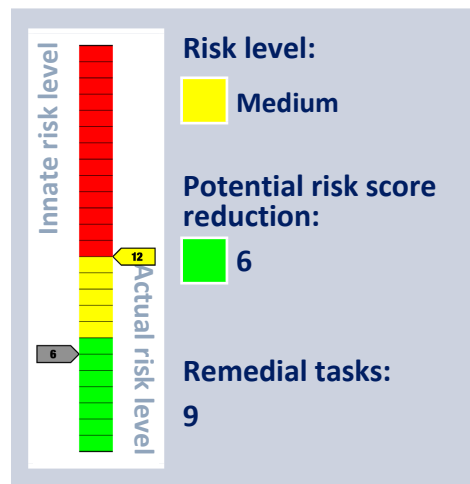
# Agility - Balance Trail

1. Loose in ground.
2. This equipment relies on one post for its stability. Special attention should be paid to maintenance (e.g. by monitoring degradation) and if necessary decommissioning the item before the end of its operating life. This is a requirement of the British Standard.
3. There are natural splits / shakes in the timbers.
4. Bolt(s) loose.
5. Laminate damaged.
6. Bolt(s) loose.
