**S19-979**

**Station Road,  
North Thoresby**

Section 19 Flood and Water  
Management Act 2010

Date Prepared – 07/05/2025

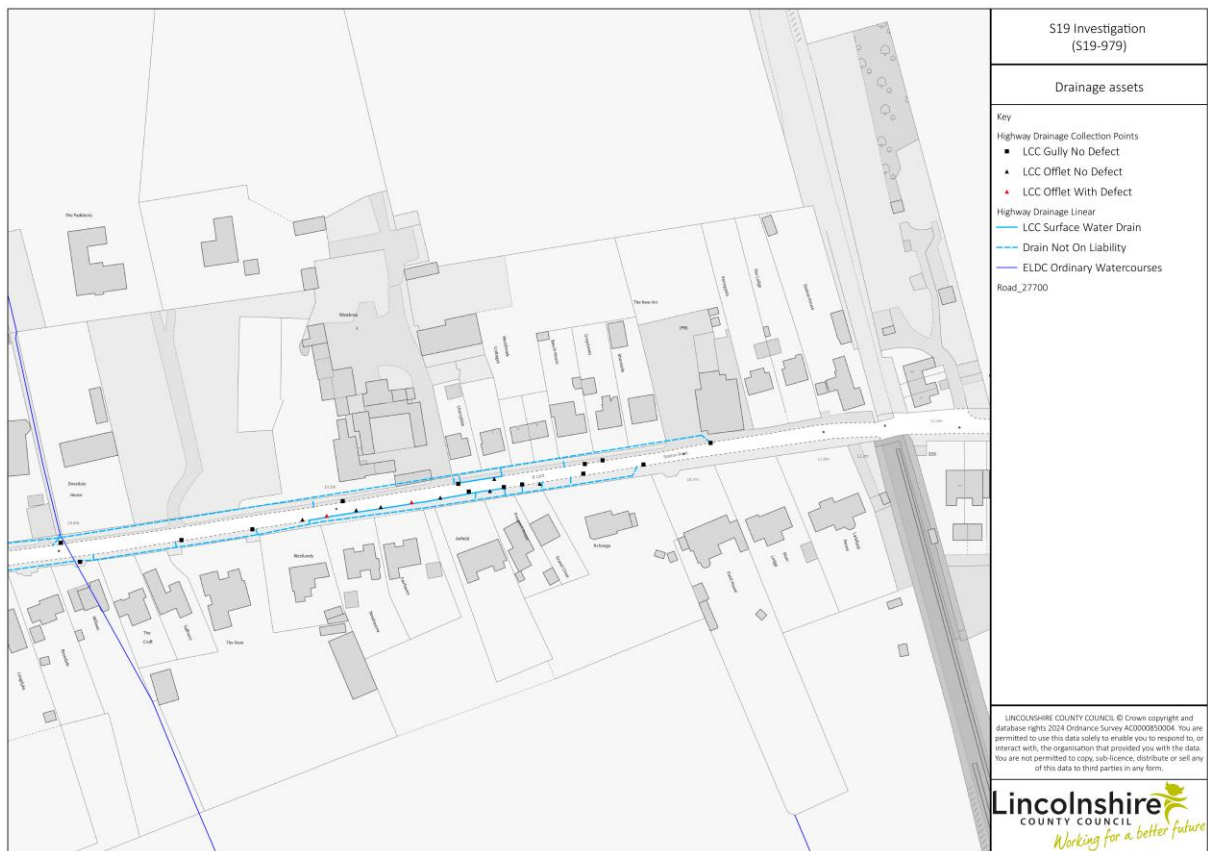
LCC records at time of publication are shown in Figure 5. This indicates that highway gullies are present along Station Road (to the south of the properties), which drain in a westerly direction to the nearest watercourse.

Gullies are noted on the northern side of Station Road, adjacent to Properties C, D and E; further gullies and offlets are noted on the southern side of the highway, opposite Properties A to B and D to E. All gullies and offlets are recorded as having an annual cleansing cycle, with the last inspection occurring on 15 May 2024. Prior to the last cleanse, the silt level was recorded as ‘amber’. No defects were noted within the assets immediately adjacent to the properties, although two offlets c. 40 m and 80 m south-west are noted to have defects.

(Figure 5 - Known drainage assets included within LCC records in the affected area at the time of publication)

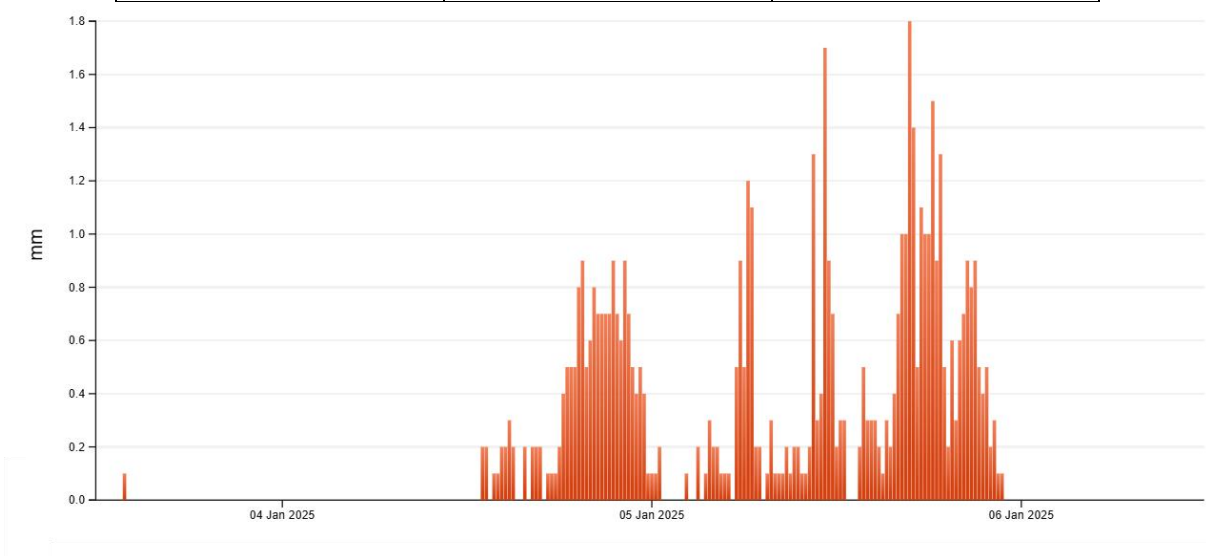
The closest rainfall gauge is located at Covenham (ref: E25033), c. 5.4 km south-east of the properties. In the absence of a closer gauge or Radar data, the rainfall data from this gauge has been analysed as part of this investigation (Figure 7).

(Figure 7 – Rainfall totals over 15 minute periods at Covenham rain gauge between 04 and 06 January 2025)

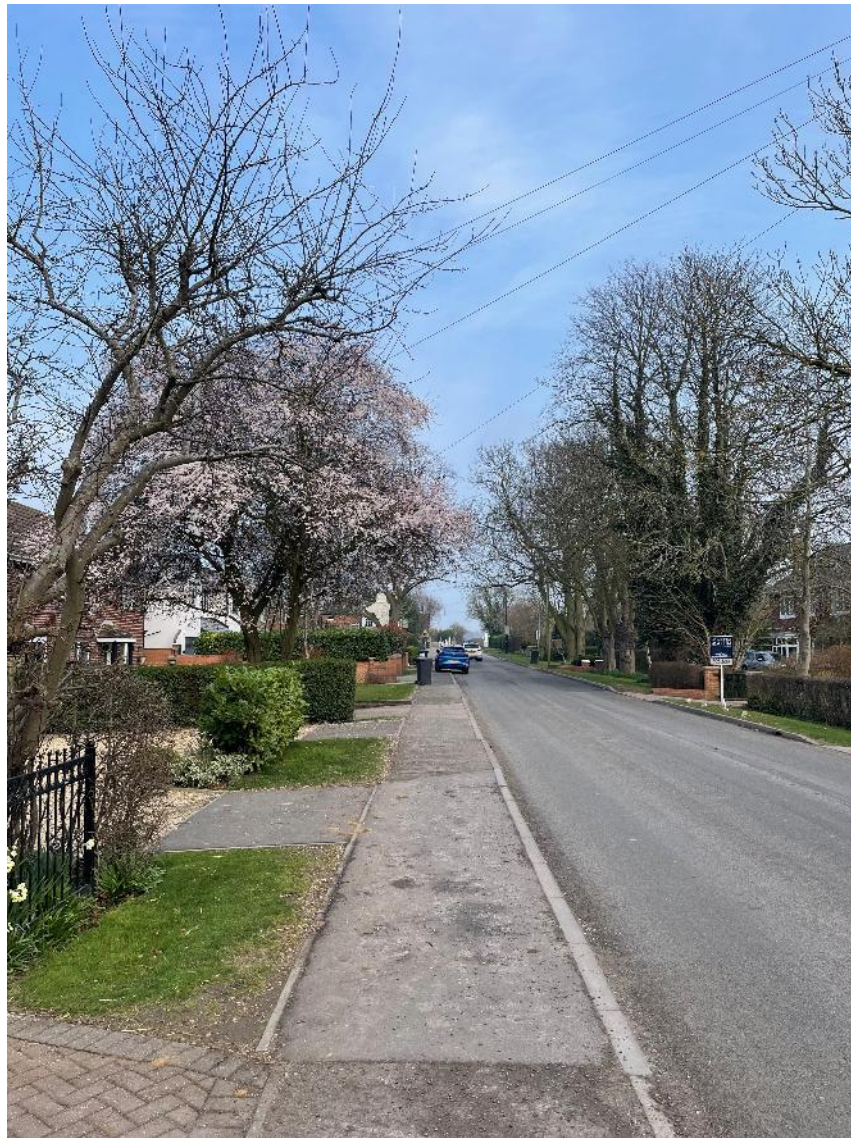
*(Photograph 3 – Station Road, as viewed from a point to the west of the properties; facing east)*
